CASE STUDY

Restoration of the Pentagon Building

Arlington, Virginia – The Pentagon is one of the most recognizable buildings in the world and has been inseparably linked with the United States Military since its construction during World War II.

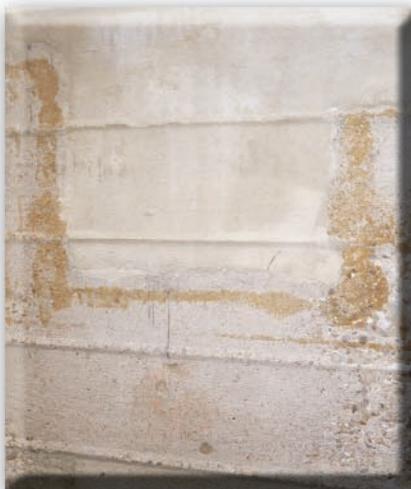
Even after patching and cleaning, the walls of the light wells were badly discolored with large variations in texture. The walls were also extremely porous.

A sealer system was required to waterproof the walls and to uniformly stain the surface without affecting the texture of the substrate.

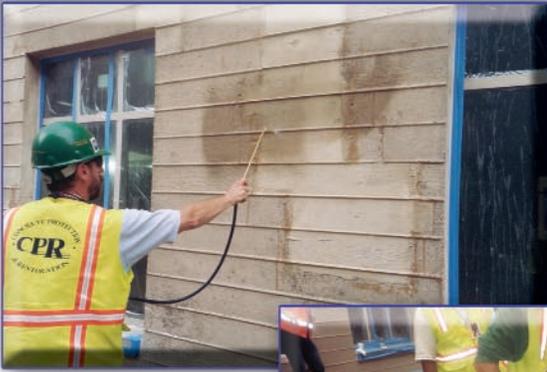
After patching, the walls are treated with a corrosion inhibitor. Then the ChemMasters system is applied.

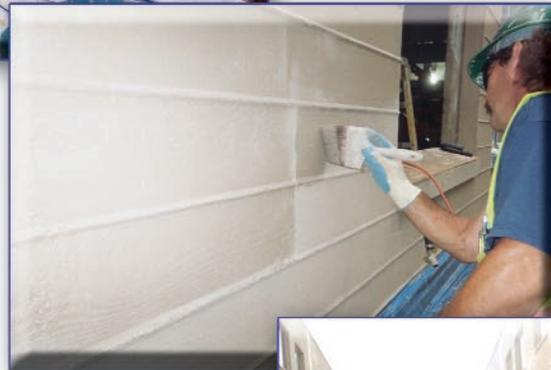
Next, two coats of **Colorsil** are applied. **Colorsil** is a water-based, single component, breathable silicate surface treatment. **Colorsil** is not a coating. **Colorsil** colors the surface without forming a film. It penetrates into the surface and chemically reacts with the free lime in the substrate to waterproof. **Colorsil** can be pigmented to match any color specification.

Brush, roller or airless spray equipment may be used to apply Colorsil. When dry, all of the texture of the substrate remains. This was a requirement at the Pentagon where the unique surface character of the poured-in-place concrete needed to remain visible on this historical building. Because Colorsil is not a film, it cannot peel from the surface. It is also UV stable so there will be no change in color.
